Check-out Document

Address	2 St Marks Avenue Harrogate HG2 8AE	House Type	House
		Detachment	End Terrace
Front Elevation		Side Elevation	Rear Elevation

08/03/2017

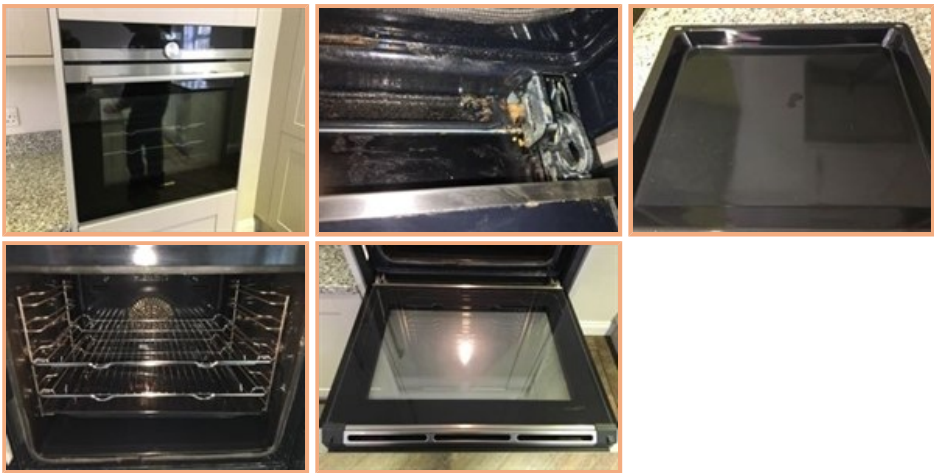
Oven, Siemens - food debris in corners of door frame. Tray stained.

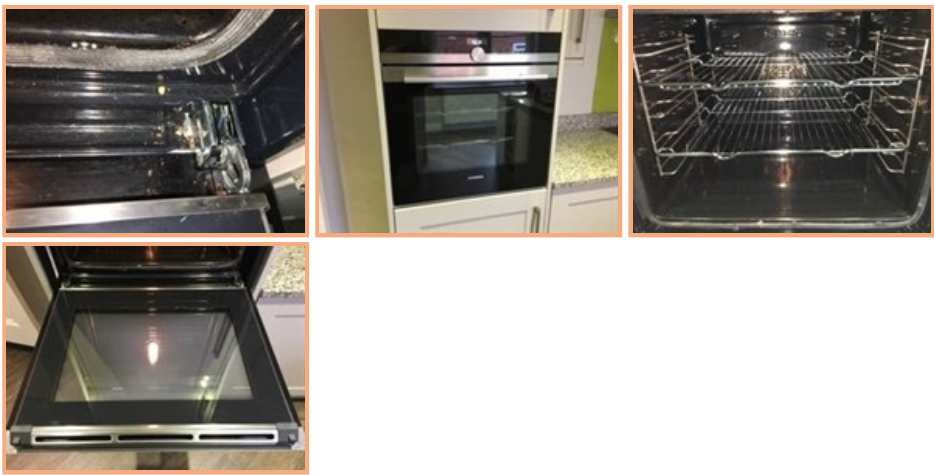
Oven, Siemens - small amount of food debris in corners of door frame

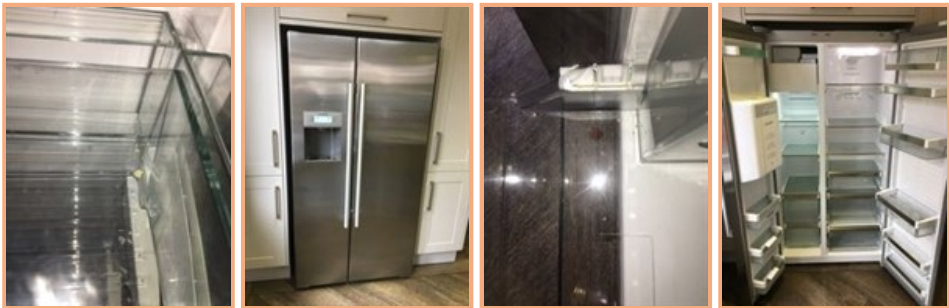
Fridge freezer, Siemens - small amount of food debris

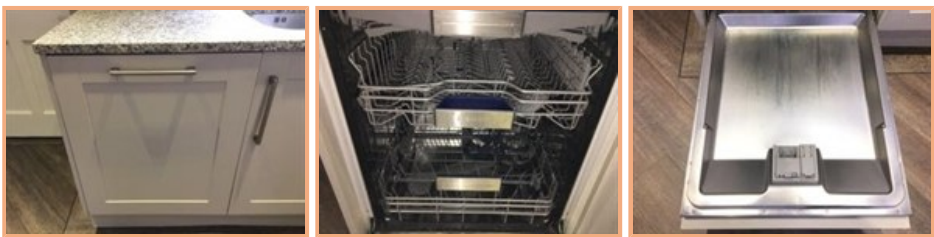
Integral dishwasher, Siemens - mostly clean, inside door lightly stained.

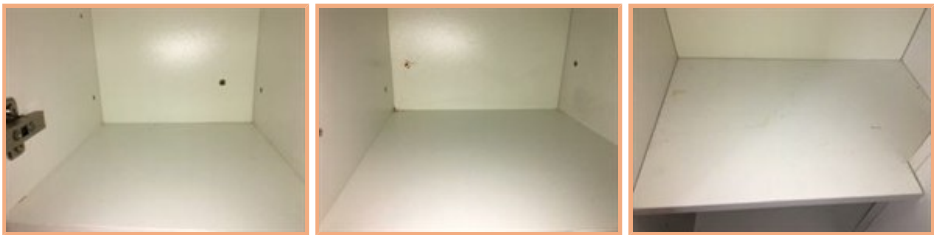
Cupboards - small amount of dust and light staining in areas

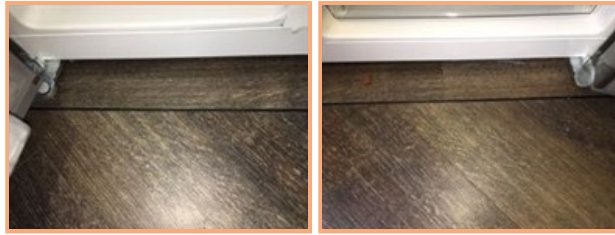
Floor dusty under fridge freezer

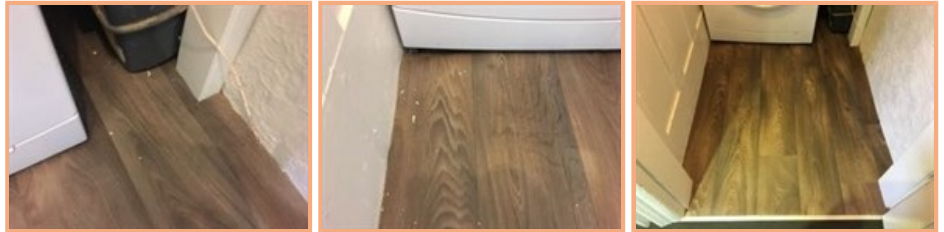
Cupboard floor dusty

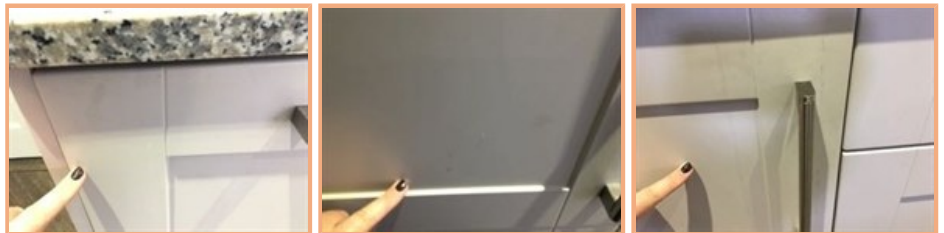
Cupboard fronts lightly stained

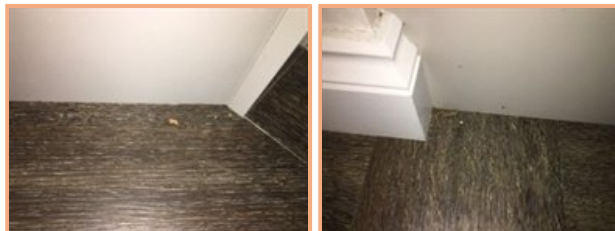
Floor dusty at edges

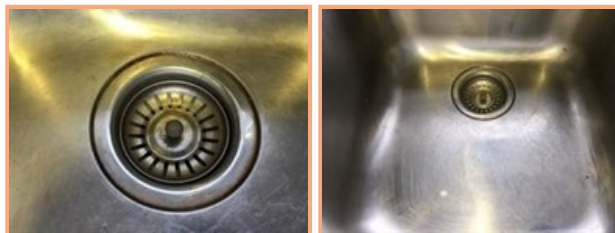
Main sink stained and small amount of food debris

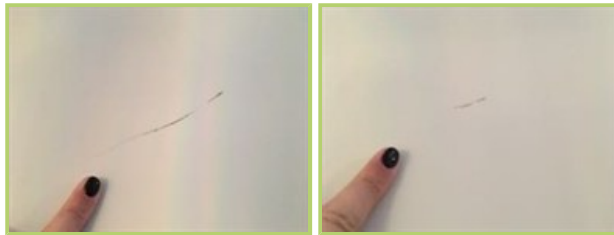
Wall marked

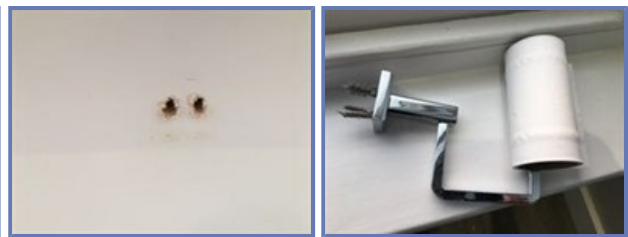
Toilet roll holder loose
